# Building Inspection Report

## Your New Home

**Report Number:**  
10-00000

**Inspection Address: Your New Home**  
**Report Number: 10-00000**

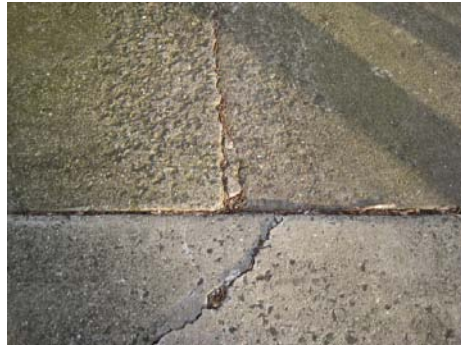
- **Repair:** The soil below the driveway at the front wall has settled and/or heaved. Persisting movement may result in the need for resurfacing.

Cracked Driveway

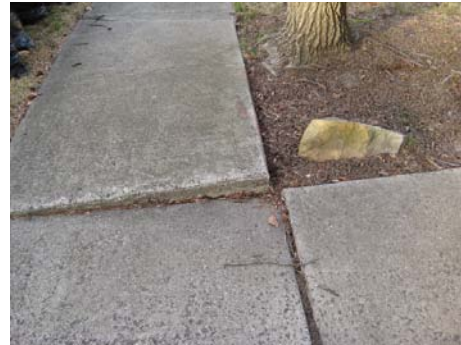
- **Safety Issue:** The walkway at the front wall presents a trip hazard. This condition should be altered for improved safety.

Trip Hazard (Front Walk)

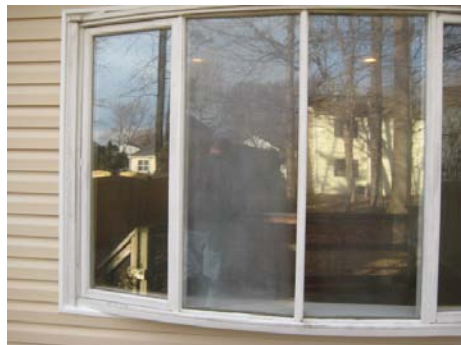
- **Major Concern:** The bay windows at the front and rear walls have lost their seal. This has resulted in condensation developing between the panes of glass. Repairs are recommended.

Broken Window Seal at Bay Window

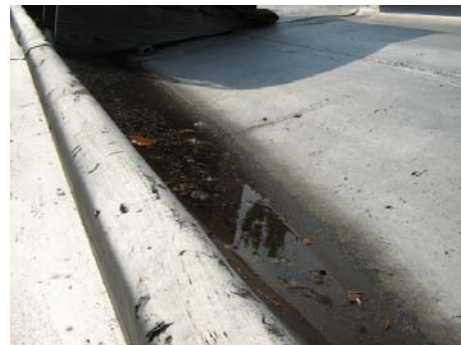
- **Repair:** Water is ponding at the eave edge near the air conditioner condensers. This area should be repaired to maintain the slope towards the roof drain.

Water Pond @ eve

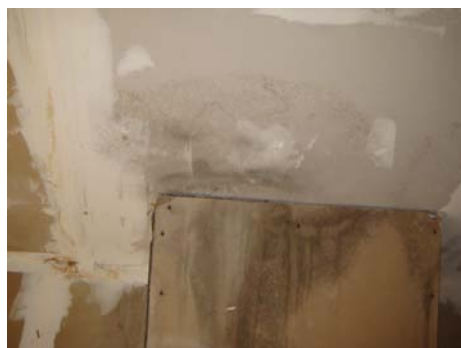
Water Leak in Garage from Chimney

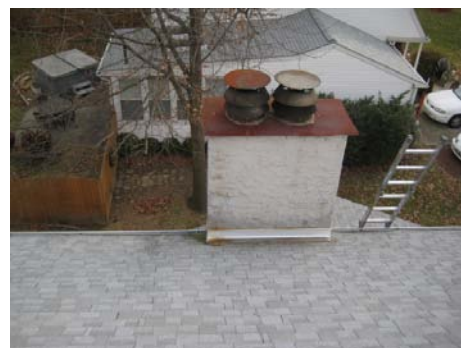
- **Monitor:** The masonry chimney at the chimney shows evidence of normal wear and tear.
- **Repair:** The metal chimney cap is rusting. It should be painted with an appropriate paint or replaced.
- **Repair:** The masonry chimney side slope is in need of a cricket installed behind it to help direct water into the gutters.

Rusted Chimney Cap

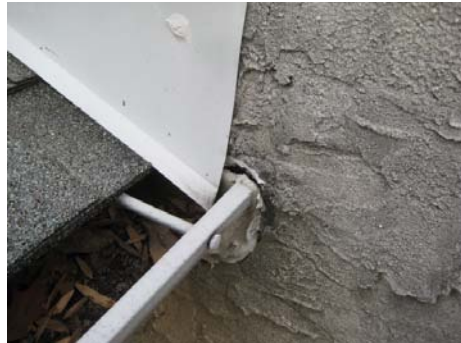
- **Major Concern:** The flashing at the chimney is damaged and should be repaired to avoid further leaks into the garage. See the photo at the end of this report.

Hole in Flashing at Chimney

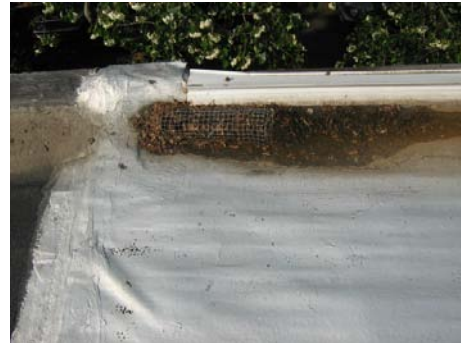
Blocked Drain

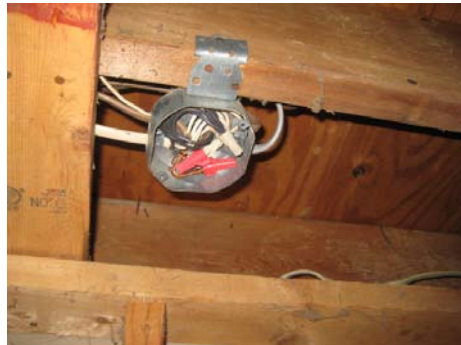
Open Junction Box

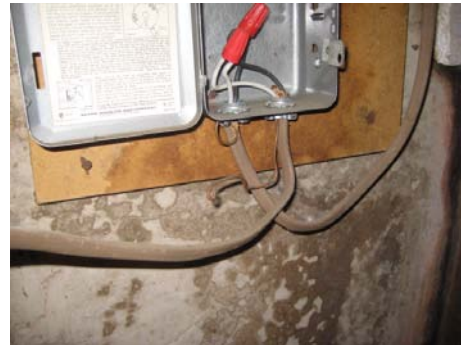
Ground Not Connected

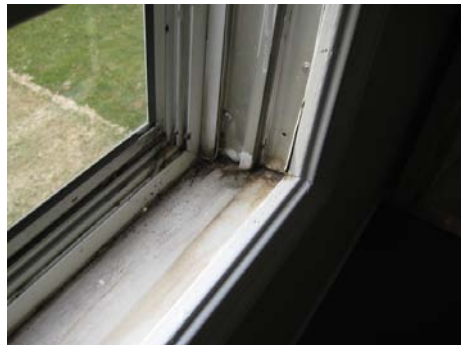
- **Repair:** The sliding glass door at the rear wall requires caulking.
- **Major Concern:** The windows in the rear bedrooms and master bedrooms show evidence of substantial rot to the window sills and frames. Repair to the windows can usually be accomplished by a skilled carpenter; however a replacement window is preferred in most cases.

Rotted Sill in Master Bedroom

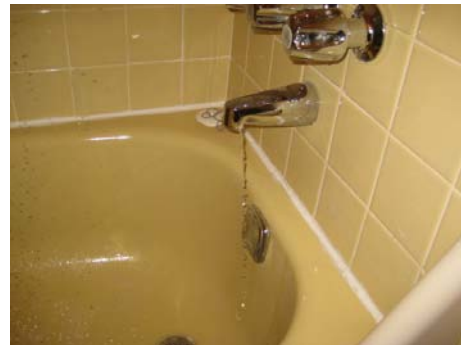
- **Repair:** The shower diverter is leaky and should be repaired.
- **Repair:** The sink is loose in the second floor hall bathroom and should be secured.

Diverter Leak

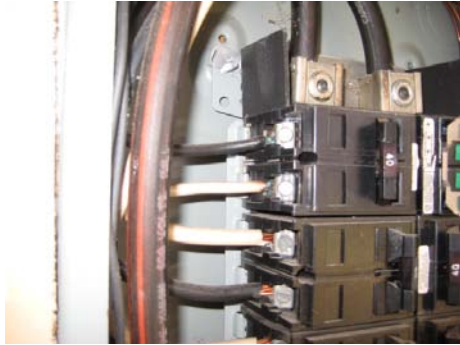
- **Major Concern:** Overheated wiring within the main distribution panel should be examined by a licensed electrician and repaired as necessary.

Scorched Wires

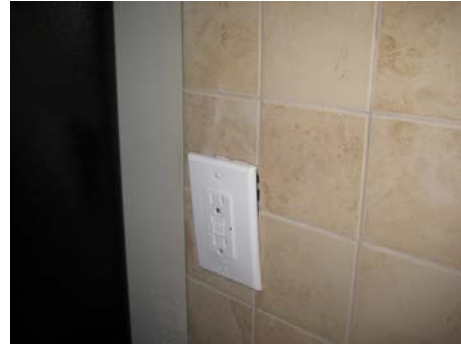
- **Safety Issue:** An outlet in the kitchen is loose. It should be replaced.

Loose Outlet

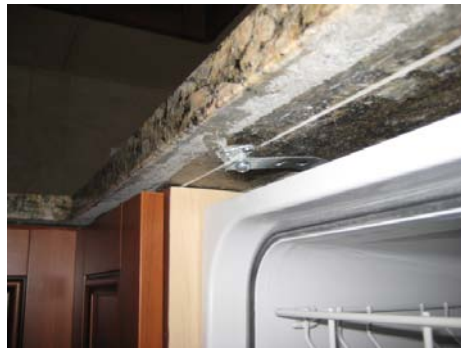
- **Repair:** The dishwasher should be better secured.

Dishwasher Loose
