Home Inspection Report

Your New Home

ValueGuard USA, Inc.

Inspection Address: Your New Home
Report Number: 10-00000

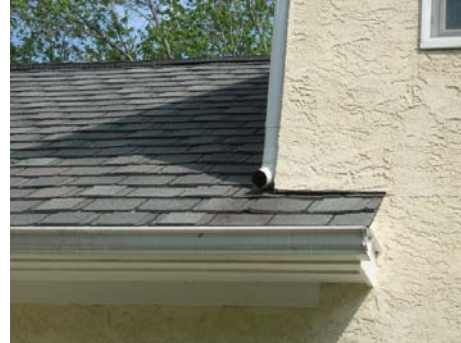
- **Repair:** Downspout(s) that discharge onto the roof should be extended to discharge directly into the gutters below. This condition, if left unattended, can result in premature deterioration of the roofing under the end of the downspout.

Downspout Emptying on Roof (typical)

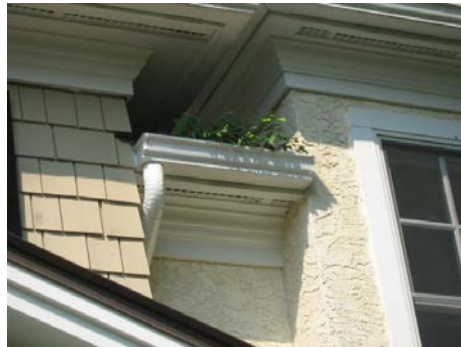
- **Repair:** The gutters require cleaning (especially at the front wall) to avoid spilling roof runoff around the building – a potential source of water entry or water damage.

Dirty Gutter

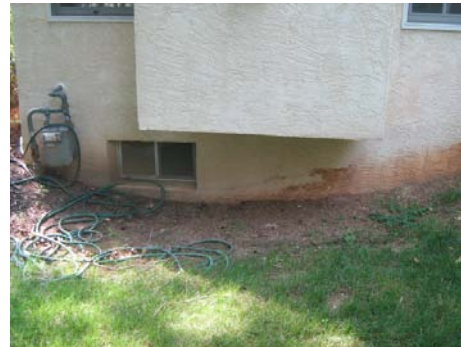
- **Repair:** The basement window well should be improved where grading has been improved at the south wall. Window wells protect basement windows from surface water and avoid rot/insect damage by preventing wood contact with the soil.
- **Monitor:** It appears as though a drainage system has been installed for the rear of the property and the gutters that discharge below grade. The drainage system is buried (not visible) however the size of the collections boxes located in the driveway indicates that it is a robust system. The builder should be consulted regarding the nature of the system. Obtaining schematics or drawings of the system would be beneficial, especially for planning any future landscaping projects.

Re-grading Needed

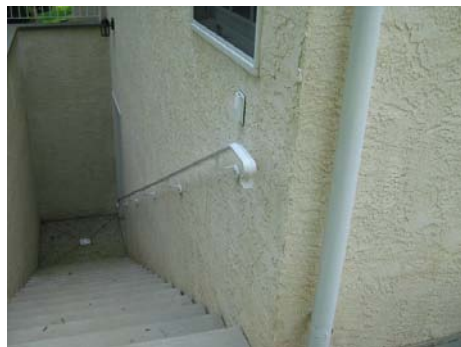
- **Safety Issue:** The handrail for the basement walkout steps is loose and damaged. Replacement of the handrail is recommended. This is a safety concern that should be addressed promptly.
- **Monitor:** The railing that surrounds the basement walkout well presents many peculiar markings (scratch marks) along the lower portion of the railing. The cause of the marks is unknown although it is suspected to be animal damage. If this becomes a problem, an animal control specialist should be consulted regarding any solutions that may be available.

Loose Handrail

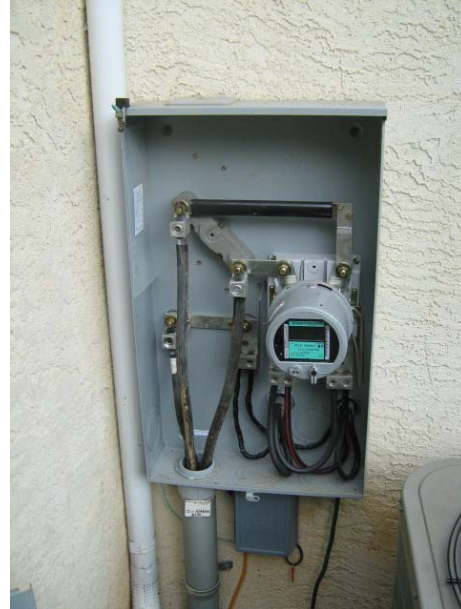
- **Repair:** A jumper wire should be installed across the water heater supply pipes to ensure proper bonding of the piping system.
- **Safety Issue:** The anti tamper device for the access panel at the electric meter is missing. The panel is easily removed, exposing various high voltage connections. The electric utility should be notified of this condition before settlement. Note: Any means of locking the panel should conform to local electric and fire safety codes.

Open Meter Box

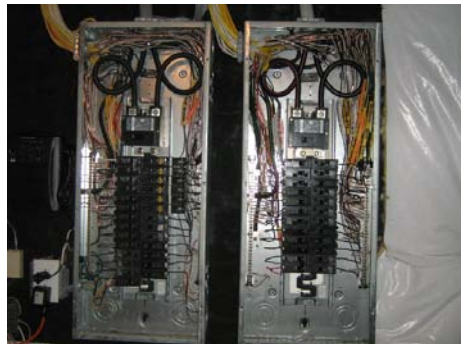
- **Repair:** Oversized breakers within the main distribution panel should be replaced. All breakers serving household branch circuits consisting of 12 gauge wire should be sized at no more than 20 amps.

Electric Distribution Panels

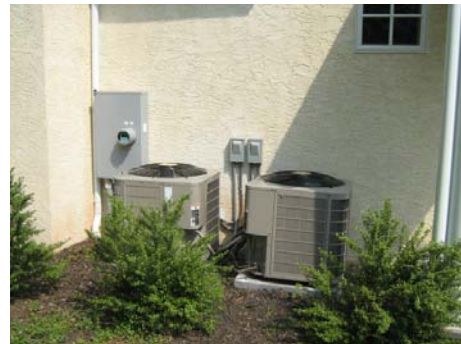
- **Repair:** Damaged/missing insulation on refrigerant lines at the air conditioning condensers should be repaired/replaced as needed.
- **Repair:** The outdoor unit of the right air conditioning system is out of level. This should be improved.

Air Conditioning Condenser Out of Level

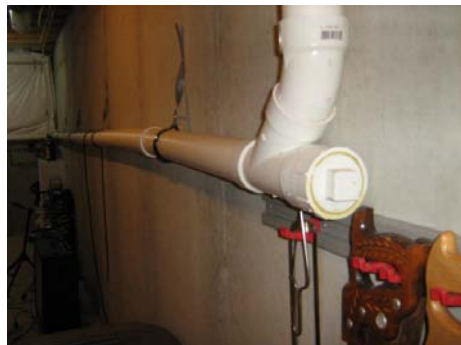
- **Repair:** The waste piping at the basement wall (east side) does not have sufficient slope for proper drainage.

Improperly Sloping Waste Piping
